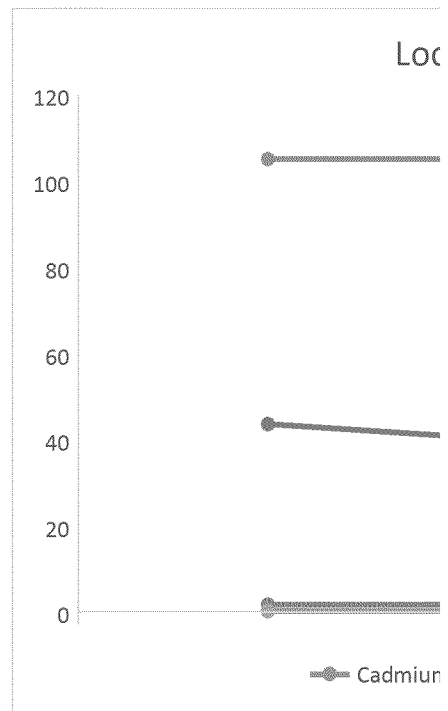
Location: 32nd Street Bridge

ocation ID	Date Sampled	Cadmium	Copper	Lead	Manganese	Zinc
32nd St Br	8/5/2015	0.178	1.7	0.24	105	43.5
32nd St Br	8/6/2015	0.16	1.56		105	37.8
32nd St Br	8/6/2015	0.19	1.62	0.115	97.8	49.1

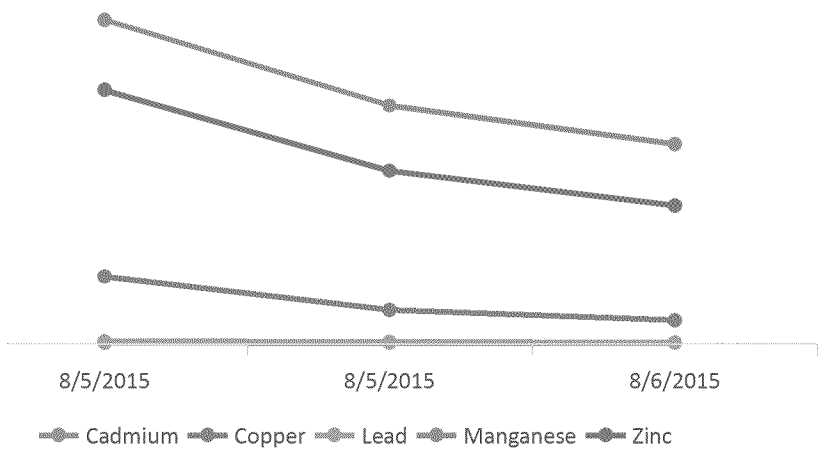
Location: CC48

ocation ID	Sampled	Cadmium	Copper	Lead	Manganese	Zinc
CC48	8/5/2015	30.6	2260	73.9	10900	8540
CC48	8/5/2015	19.1	1130	54.1	8020	5820
CC48	8/6/2015	14.2	786	30	6720	4650
